SAFETY AND RELIABILITY OF MEDIUM VOLTAGE SWITCHGEAR WITH SOLID INSULATION

W.M.M. Menheere
Eaton Holec
The Netherlands

SUMMARY

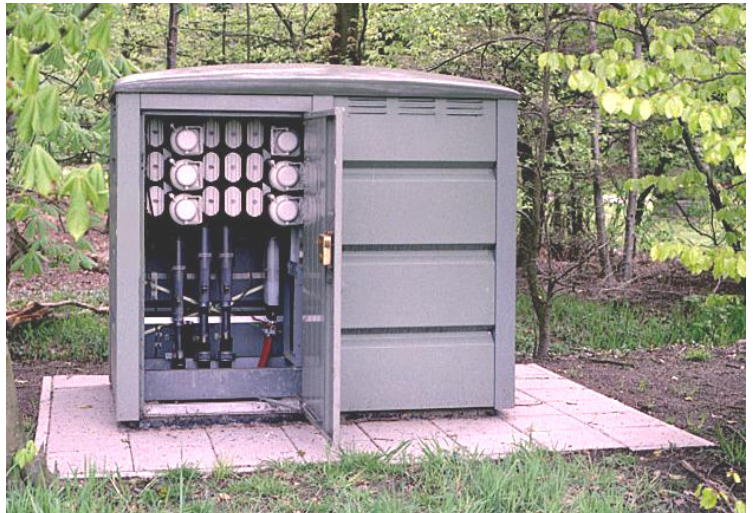
The basic concept and shape of Magnefix -modular built, double insulation, extreme compactness, and magnetic fixation of the moving contacts- was well received by the market and has been maintained for the designs of later years (fig. 4).

fig. 4 Magnefix type MD4 Ring Main Unit (RMU)

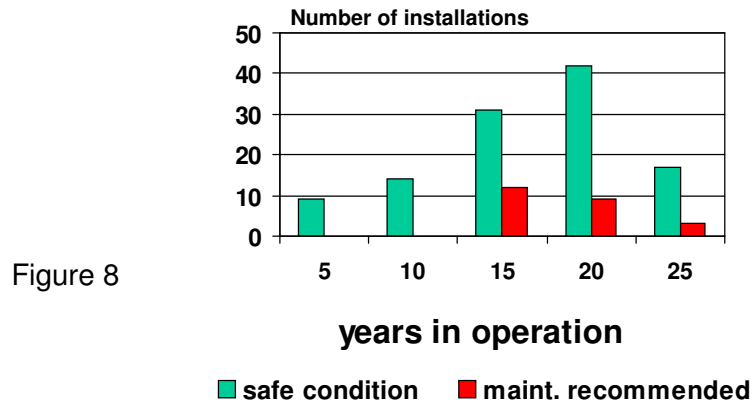
These results can be related to the number of years in operation and to the type of the accommodation. The relations are given in the diagrams of figures 8 and 9.

Figure 8 shows that no installations installed after 1977, require maintenance in the near future

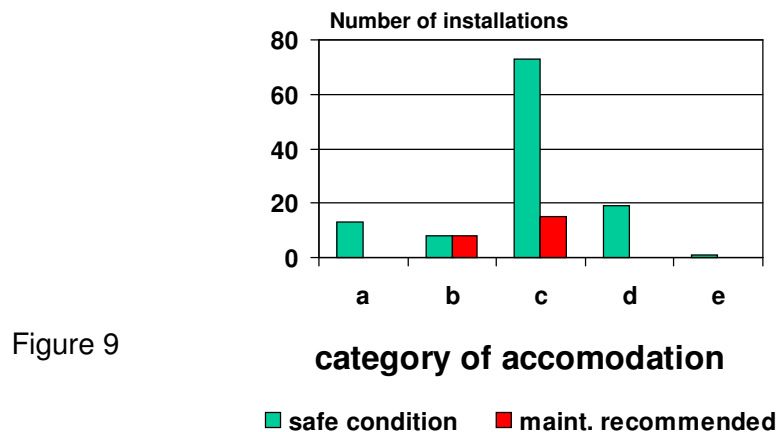
Figure 9 shows that the installations in the accommodation of the categories a, d and e are in an excellent condition, and that the accommodation of type d, made of brick, offers better service conditions for the switchgear than accommodation type c, made of metal.
